JAK/2013/PI/H/17 REV.

# Conserving the Borobudur Temple for the Future

# Today's Stone Conservation Approach

# Structural Stability Monitoring

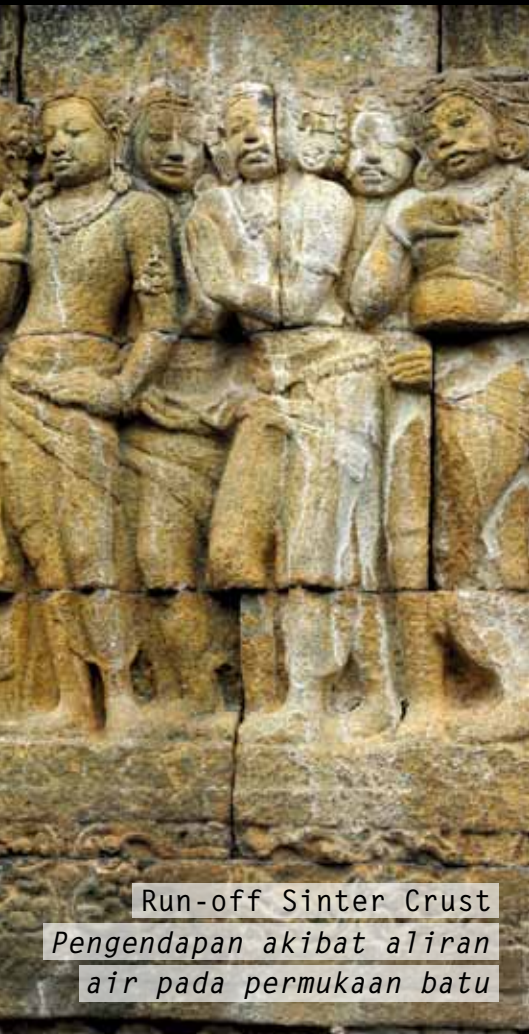
Run-off Sinter Crust  
*Pengendapan akibat aliran  
air pada permukaan batu*

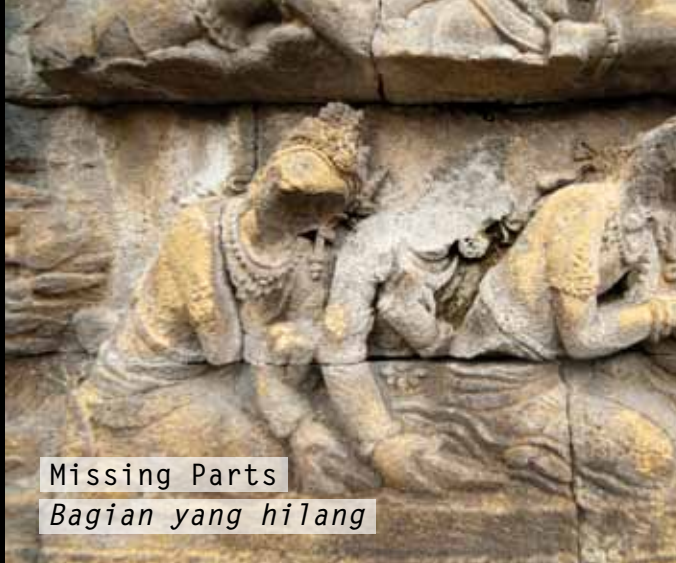
Missing Parts  
*Bagian yang hilang*

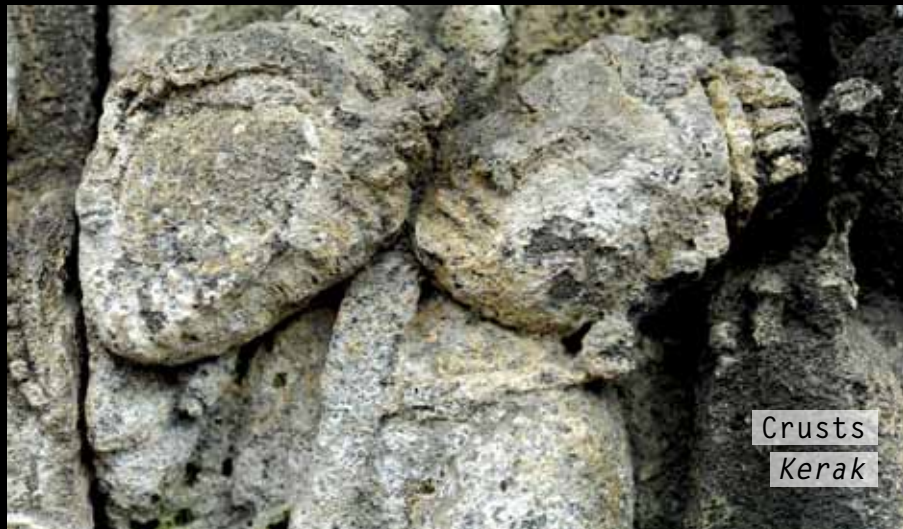
Crusts  
*Kerak*

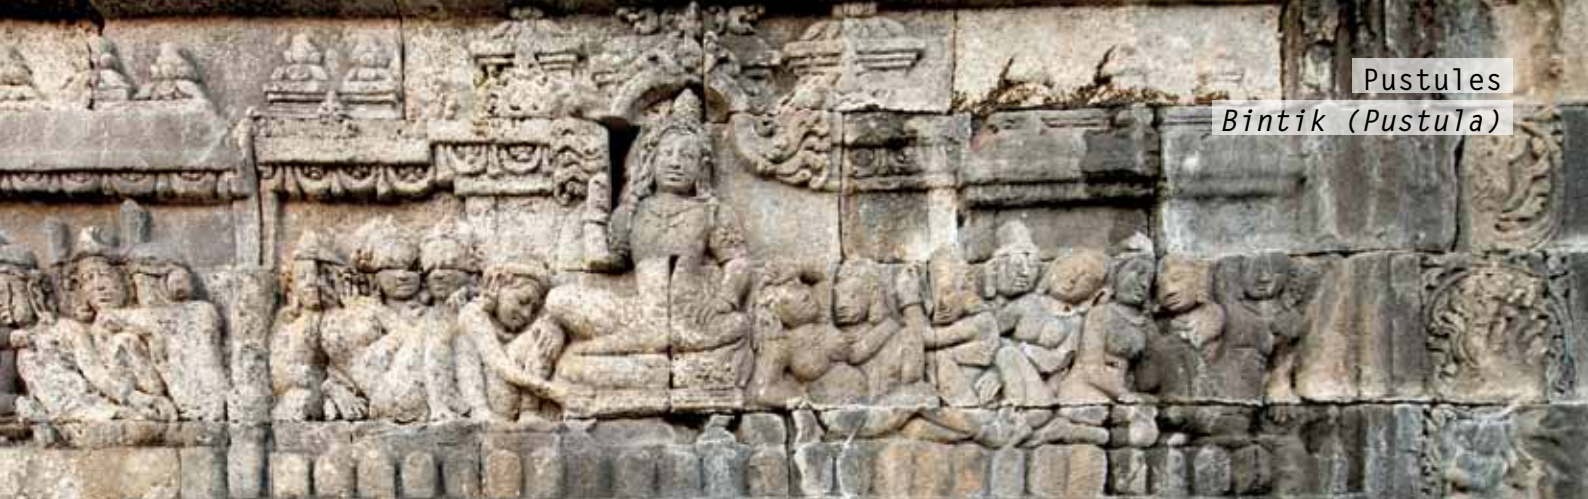
Pustules

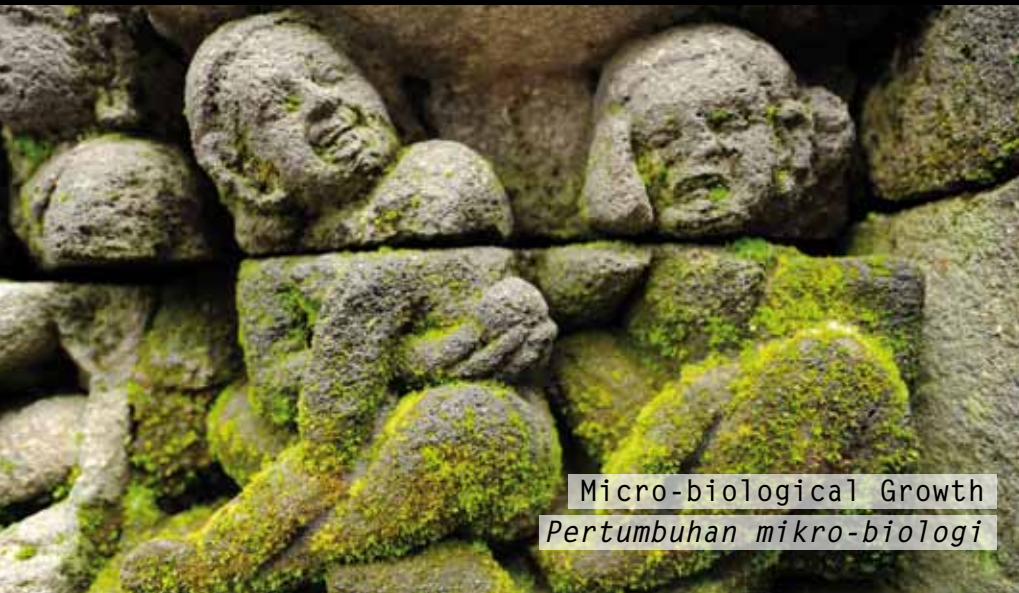
Micro-biological Growth

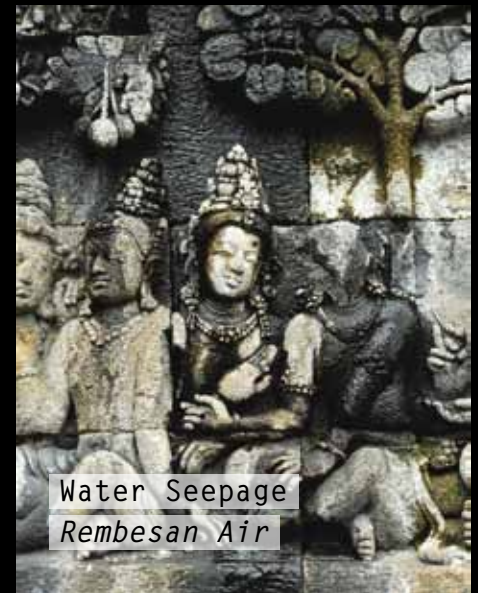
Water Seepage

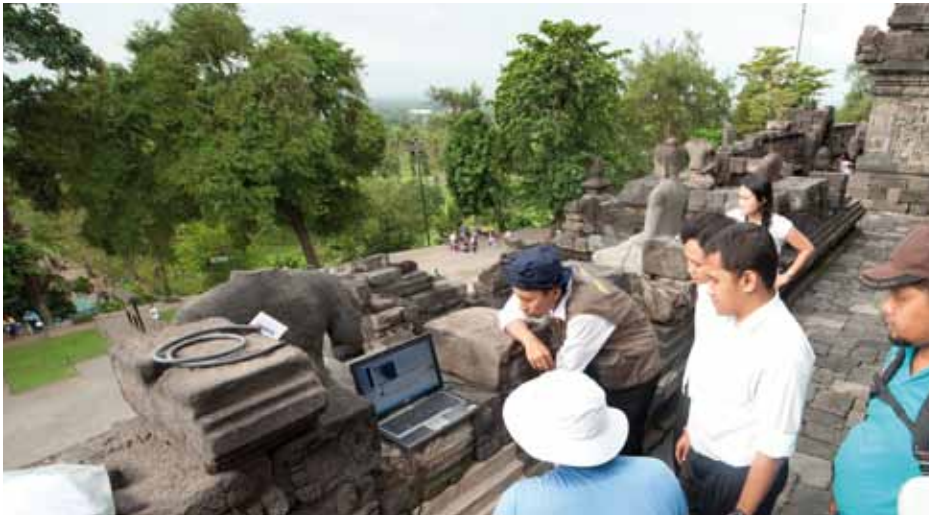
The successful operation of Borobudur's internal drainage system is checked by endoscope cameras.

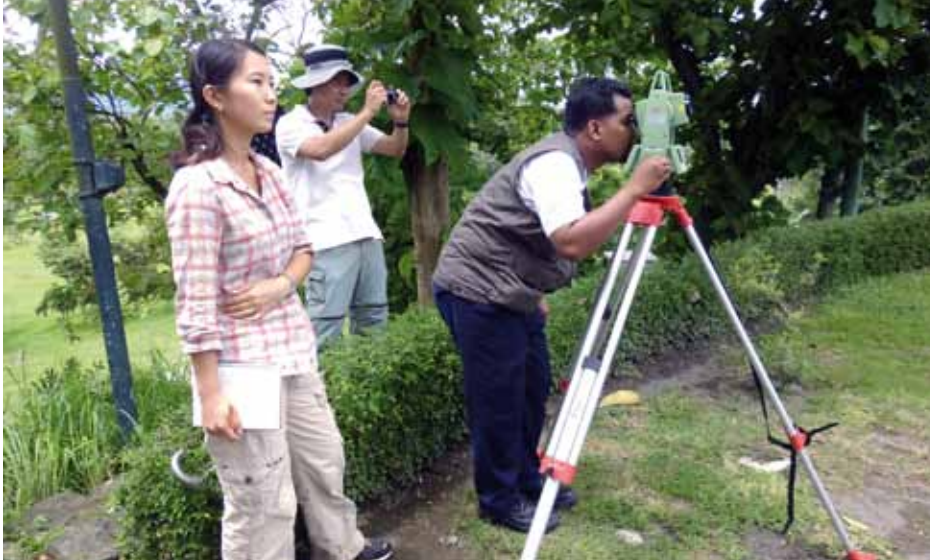
Structural monitoring by GPS  
and digital inclinometer.

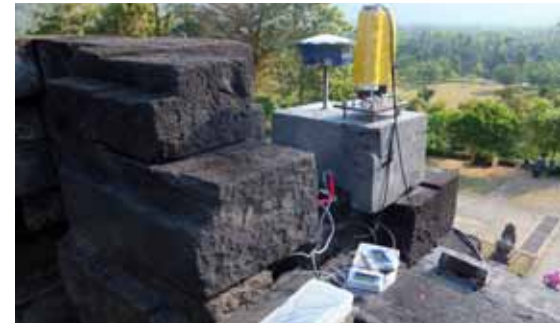
Using the Total Station to  
monitor the entire behavior of  
the stone structure and hill.
